The Middleton House

Architectural History

505 Newark Rd
Landenberg, PA

by David Hawk
Historical Narrative by Peg Jones
Photos by Chris Robinson and David Hawk
New Garden Historical Commission

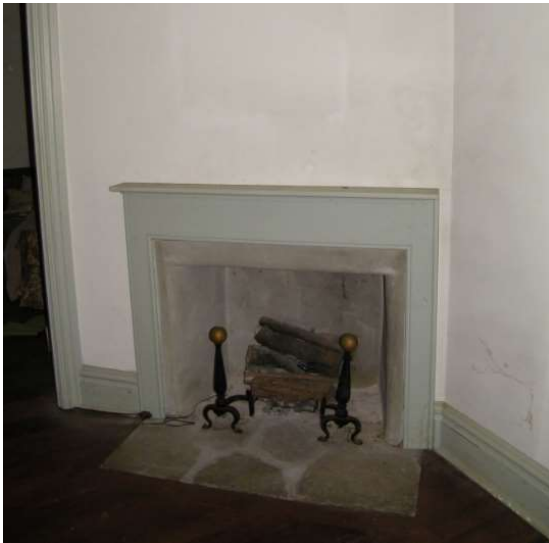
One of the corner fireplaces on the first floor

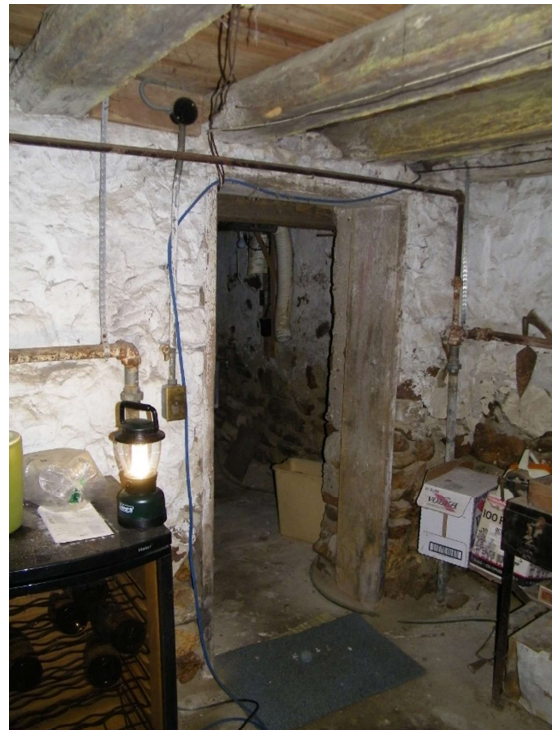
The original basement had log ceiling joists.

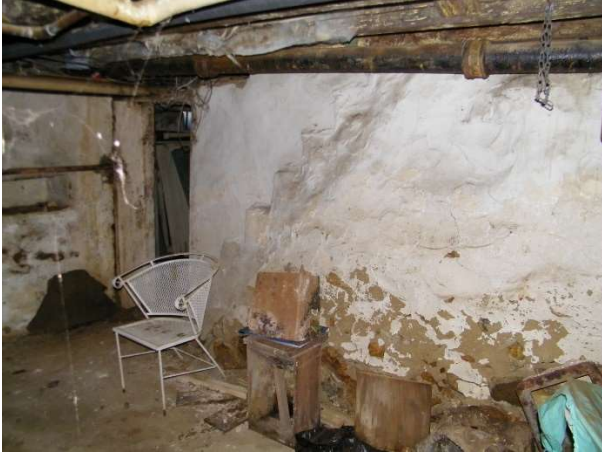
The wall between the basement below the small kitchen and the original basement as viewed from the small kitchen side (note doorway into original basement at left).

This side of the wall would have been buried when the original house was built. The plastered over bulge in this wall suggests that the small kitchen was constructed after the original house since the finish would have been better if it were meant to be exposed rather than buried.

Note also the indication of stairs leading up to the kitchen area in the plaster above the bulge. It is not known at what period these were used.

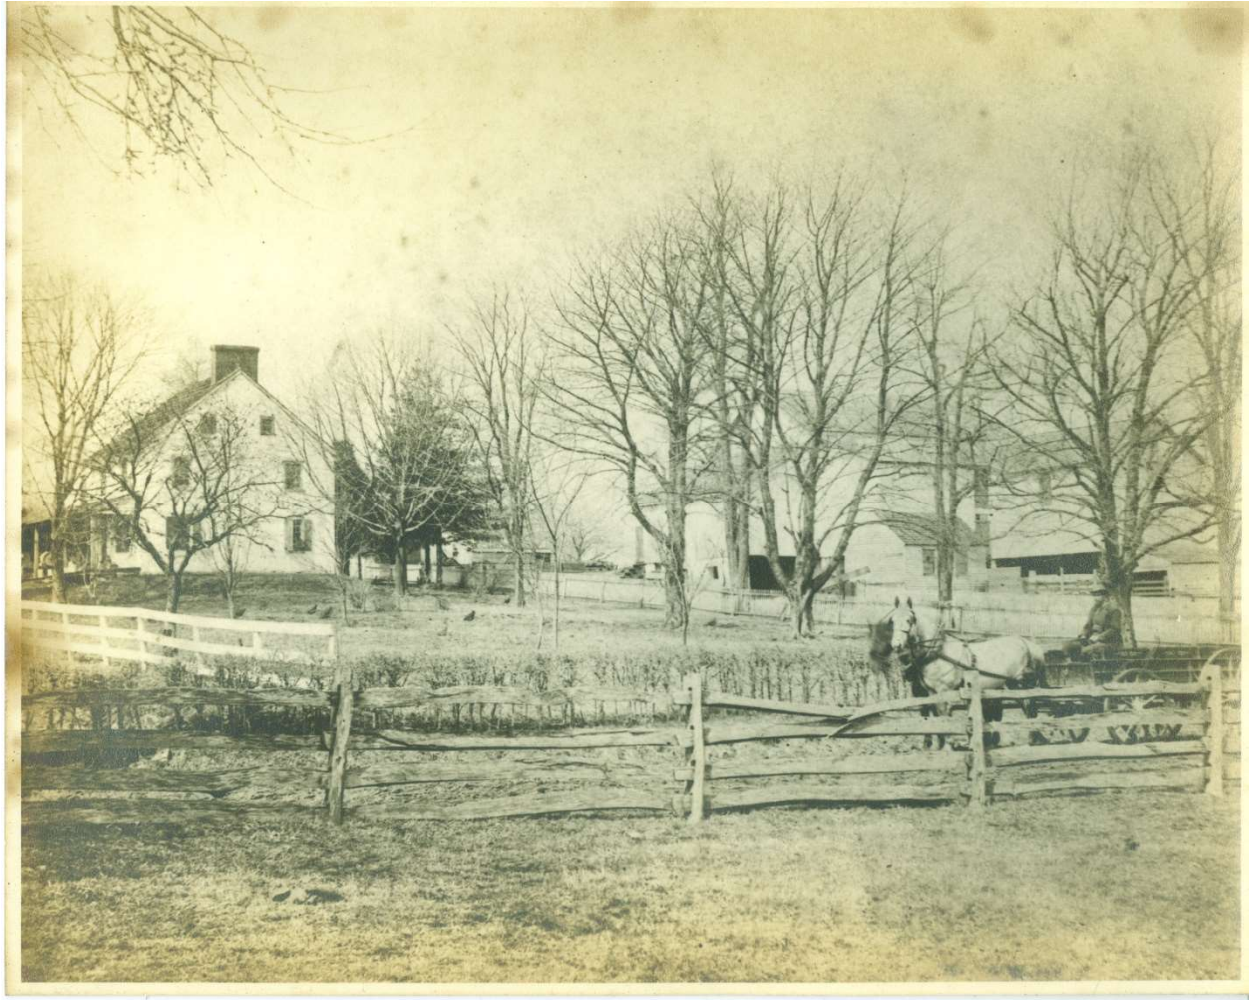
The “1880” view of the house and barn. The 1883 Breou’s Farm Atlas shows the barn north of the house, thus this photograph was taken from the east. The horses and wagon are driving south along what is now Newark Rd.

The house from the vantage point shown in the “1880” photograph would have looked very much like the original Period I house. The original chimney for the corner fireplaces can be seen.

A porch can be seen on the south side of the house. All the tree limbs in the photo obscure this, but it seems that the porch runs deeper than the original house (as indicated by the length of the second story roof line). It probably ran to the back wall of the one-story expanded kitchen.

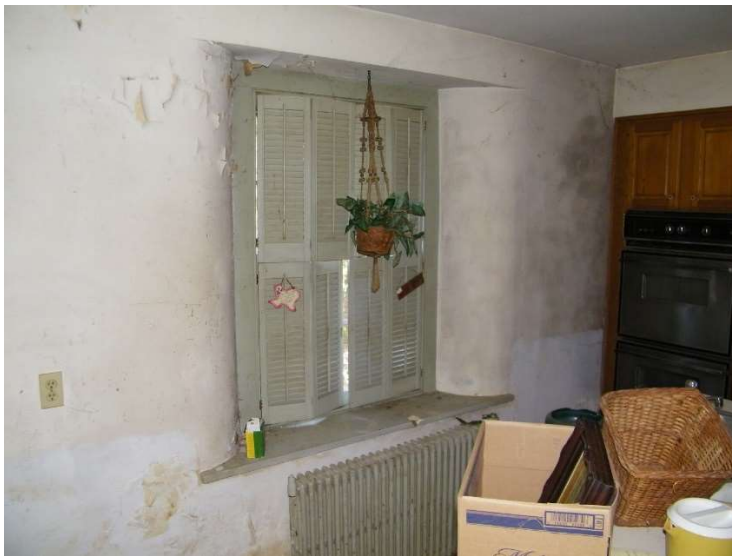
The construction date for Period III is thought to be between 1820 and 1850 based on the presence of a bull-nose window on the west wall of the expanded kitchen. This is the only bull-nose window in the house. We believe bull-nose windows were popular in the area between 1820 and 1850.

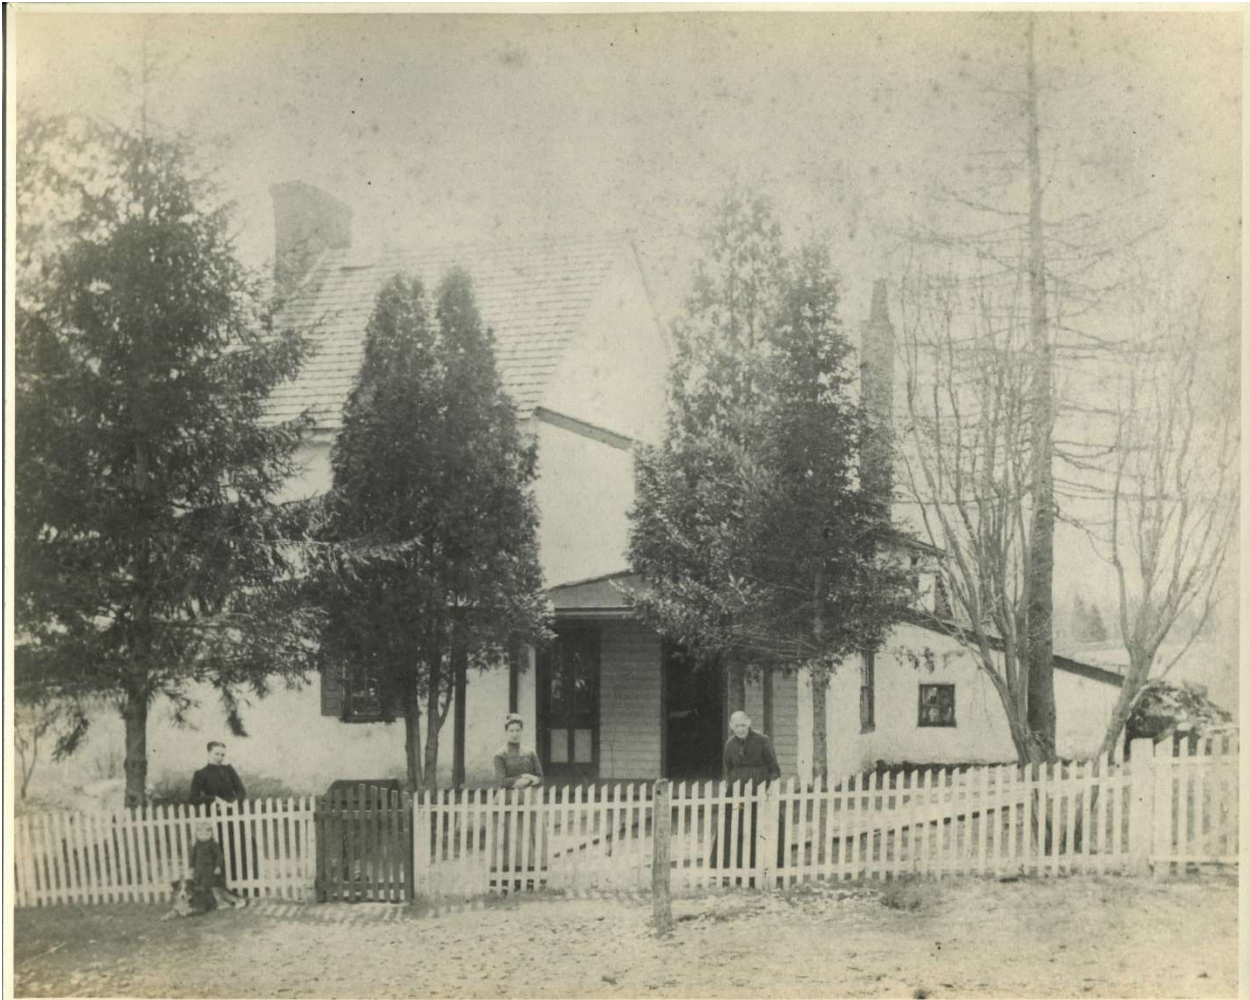
The “1888” photo of the house.

The “1888” photo was taken from north side of the house slightly to the west. The front part of the house to the left retains its original appearance - the roofline ridge still runs east-west and the original chimney for the corner fire places is still there. The expanded one-story kitchen from Period III is shown. It has two doorways and a small porch. The northern wall of the expanded kitchen appears to have wooden siding. The western wall of the expanded kitchen does not have wood siding and is probably be stucco over stone.

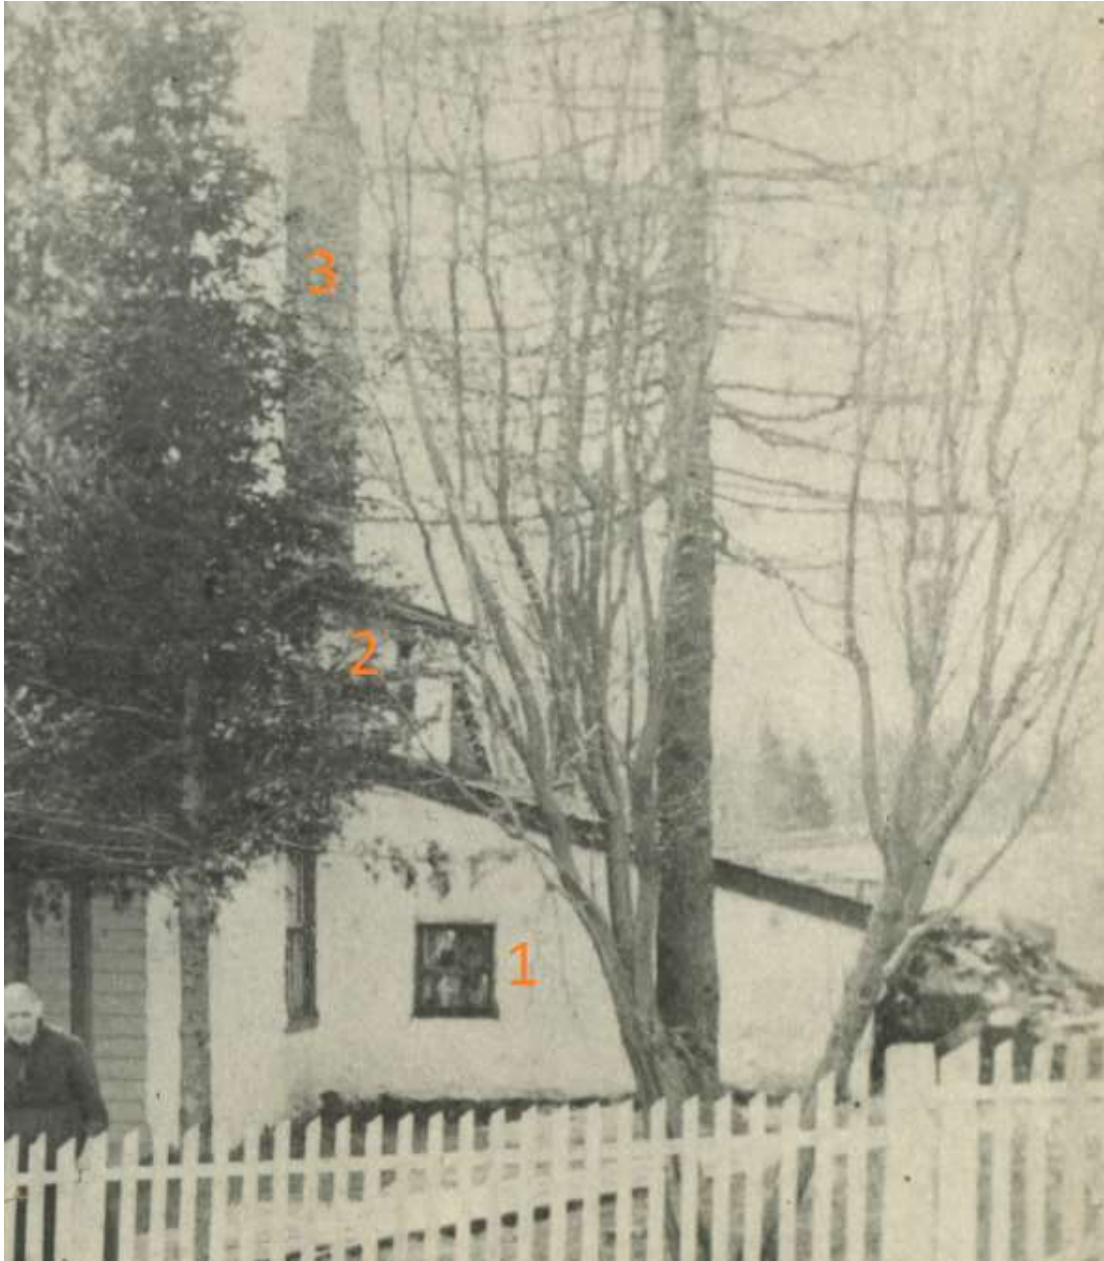
An enlargement of a portion of this photograph shows some interesting details:

1. There is a small lean-to addition approximately where the breezeway is now.
2. There is a new two-story addition extending the house to the south.
3. There is a very tall structure, possibly a chimney.

Although it cannot be seen in this photo, the surviving foundation suggests that the two-story addition was probably the same width as the southern wall of the original house and its roofline probably ran north-south since no gable can be seen in this photo.

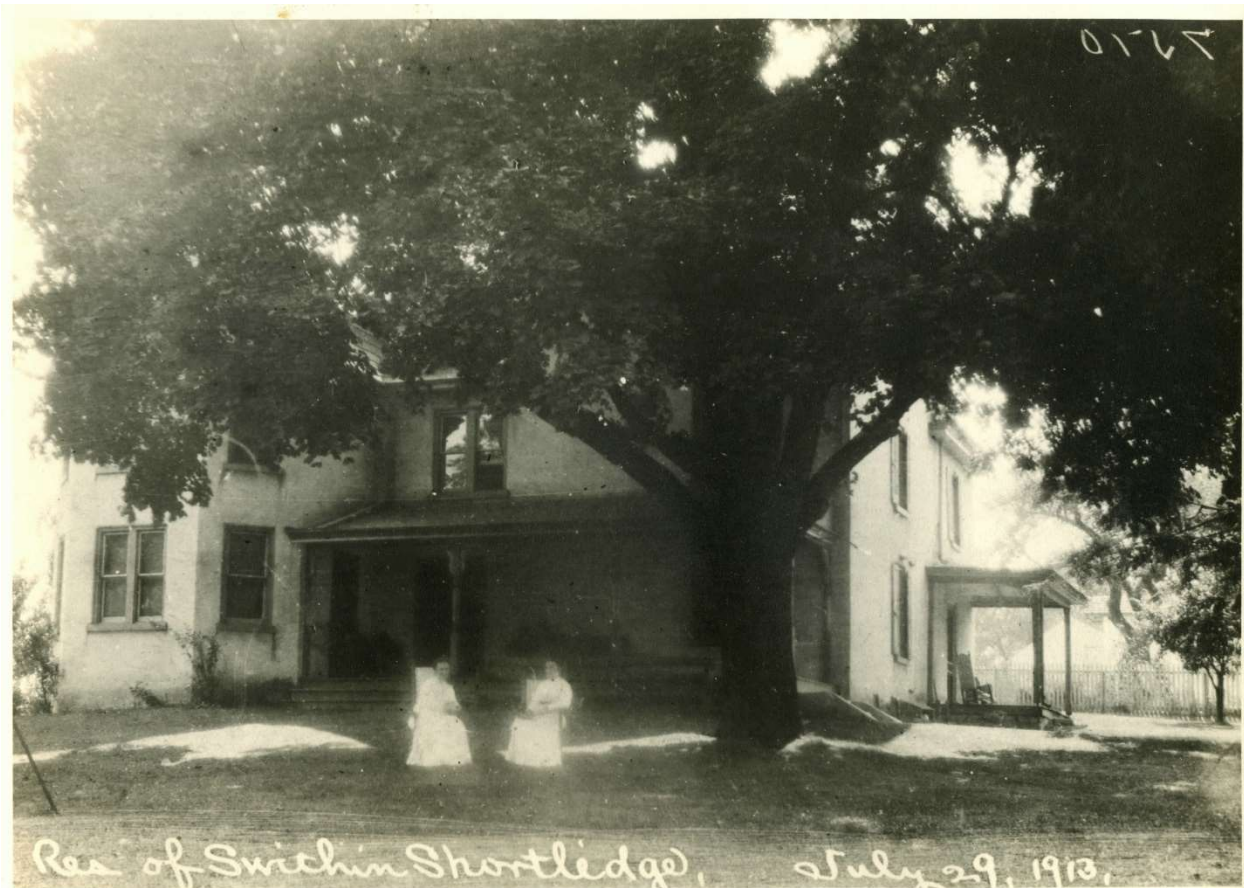
The "1894" Photo

The "1894" photo was dated July 29, 1913 and was taken from slightly north of due east and shows the results of the 1894 construction episode.

There is a new turret on the SE corner of the house. There is a front porch and an entryway on the east side of the original house. A brick second story has been added above the old expanded kitchen, and there is a small porch over the entryway to the kitchen.

The "1894" photo is inscribed on the front "July 29, 1913" which would have been when the photo was taken. 1894 is one of our known construction episodes from the Daily Local News article.

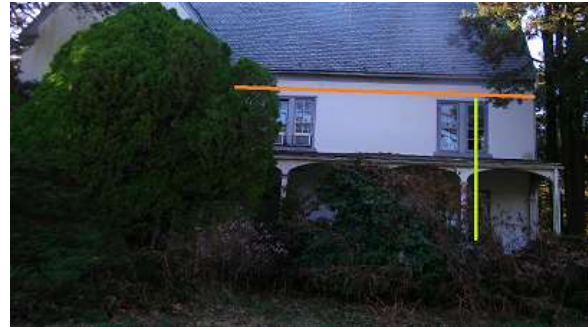
Is “1880” a photo of the Middleton house?

There are some obvious dissimilarities. The roofline is oriented differently, the windows are narrower, and there is a window where the front doorway is now. However the photo does show the now-missing chimney for the two back-to-back corner fireplaces.

The orange lines show the width of the original house, and the green lines show the distance from the top of the second floor window to the sill of the first floor window. Counting pixels, the ratio of the length of these lines is 2.15:1 and 2.17:1, a fairly close agreement (better than deserved given the different camera angles and the obscuring shrubbery).

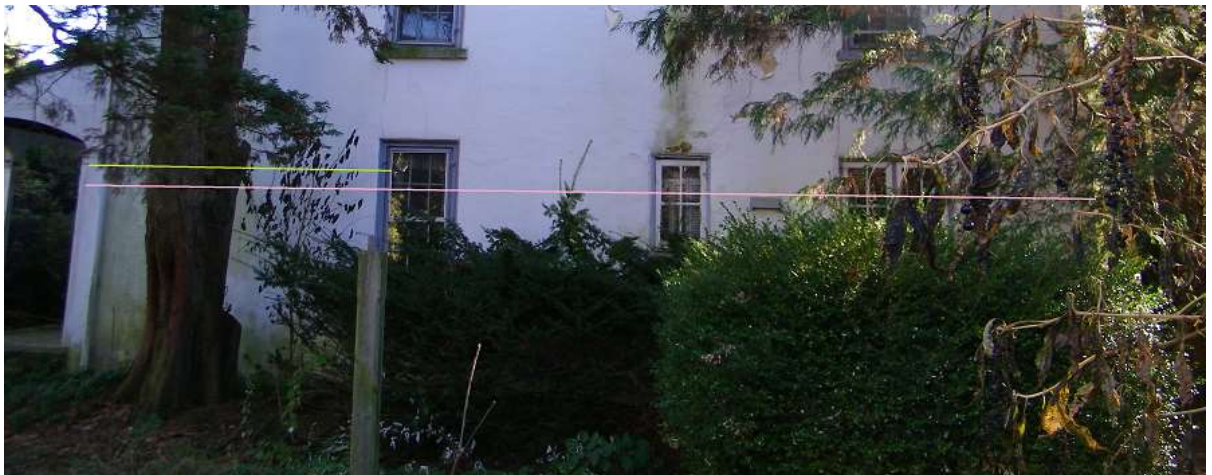
Is “1888” a photo of the Middleton house?

The green line in both of the above drawings is the distance from the NE corner of the house to the left side of the opening for the window in the den. The orange line is the distance from the NE corner to the NW corner. The measured lengths of the distances are 128” and 419” for a ratio of 3.27:1. Counting pixels on the old photograph, the ratio is 3.26:1.

All this tends to confirm that the three old photos are indeed of the Middleton House.
